# Fatigue response of pretensioned concrete beams

# **Fatigue Response of Pretensioned Concrete Beams**

## **Thesis**

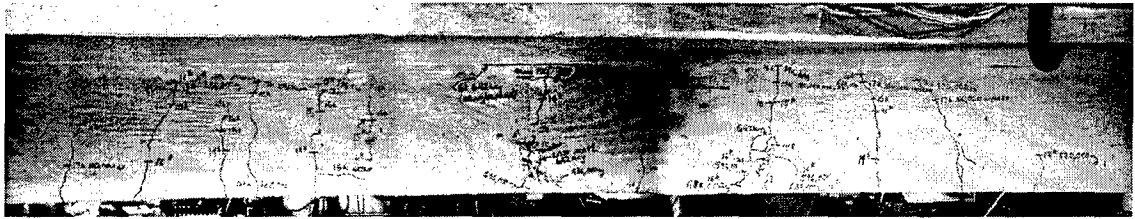
***Figure 4-14 Composite Photograph of Beam 4 at End of Fatigue Tests***
